Windows

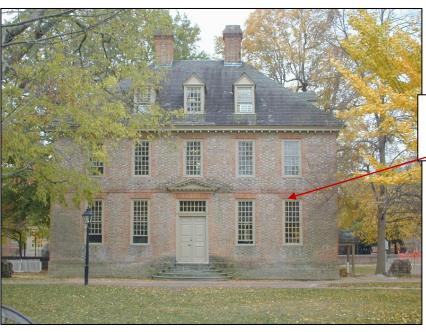
Recommended: Repairing the existing windows "in-kind;" or if existing windows are *too deteriorated* to repair installing compatible and energy-efficient replacement windows that match appearance, size, design, proportion, and profile of existing historic windows and that are durable (no vinyl), repairable, and recyclable.

Original windows were removed, repaired, and reinstalled.

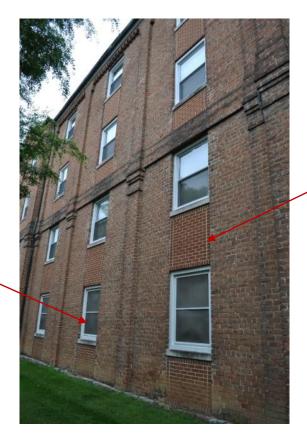
Not recommended: Completely removing and installing incompatible or inefficient replacement windows units that are not durable, recyclable, or repairable when existing windows are *deteriorated beyond repair* or missing.

Inappropriate brick fill to downsize windows.

Inappropriate doublehung, replacement window.

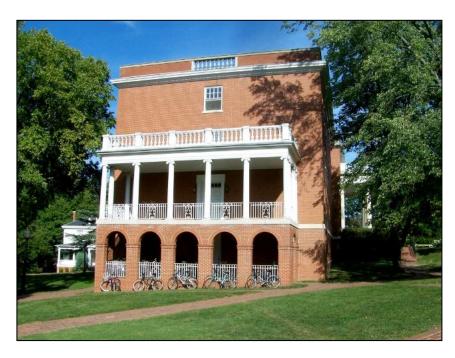
Recommended: Retaining and repairing durable historic materials, including windows.

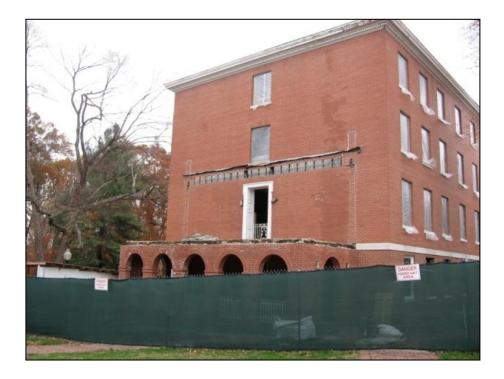
Not recommended: Removing durable historic materials, including windows, and replacing them with materials perceived as more sustainable; e.g. replacing repairable windows with new windows for perceived energy performance.
